**Building at Rear of 24 High Street, Wisbech,
Cambridgeshire : Historic Building Recording**

June 2019

Building at Rear of 24 High Street, Wisbech, Cambridgeshire: Historic Building Recording

Event No. ECB4580

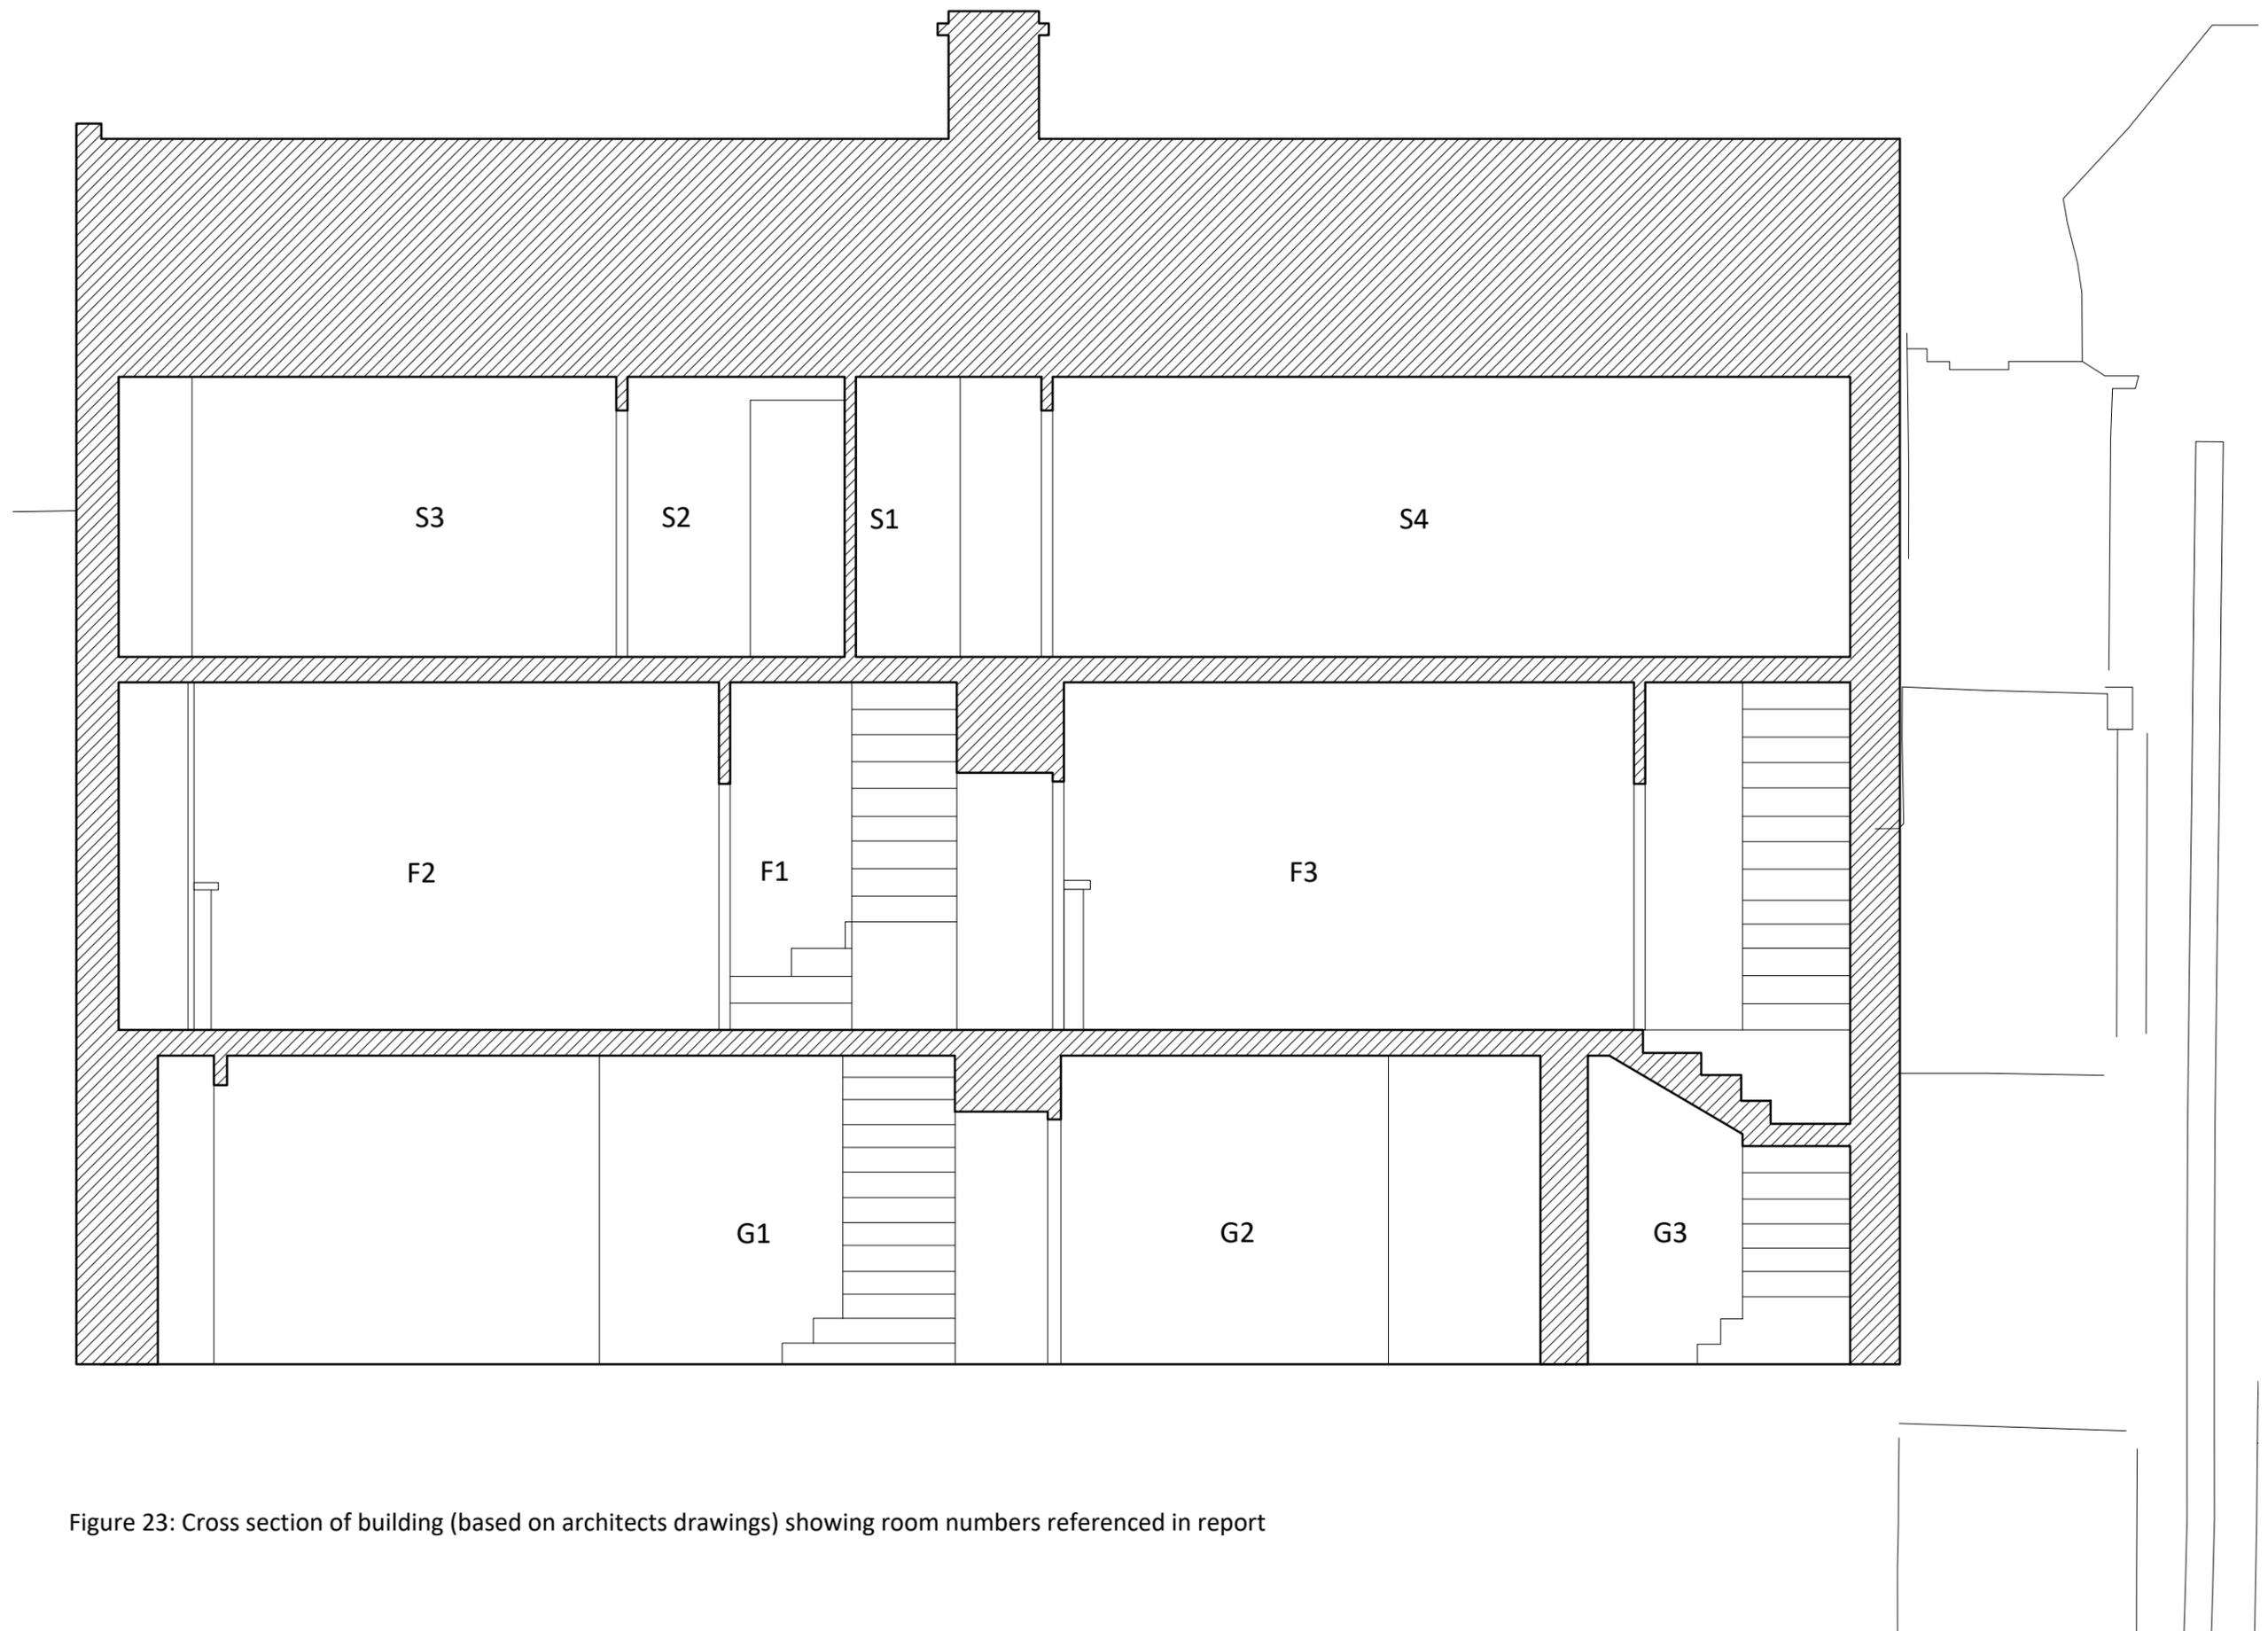
Figure 23: Cross section of building (based on architects drawings) showing room numbers referenced in report

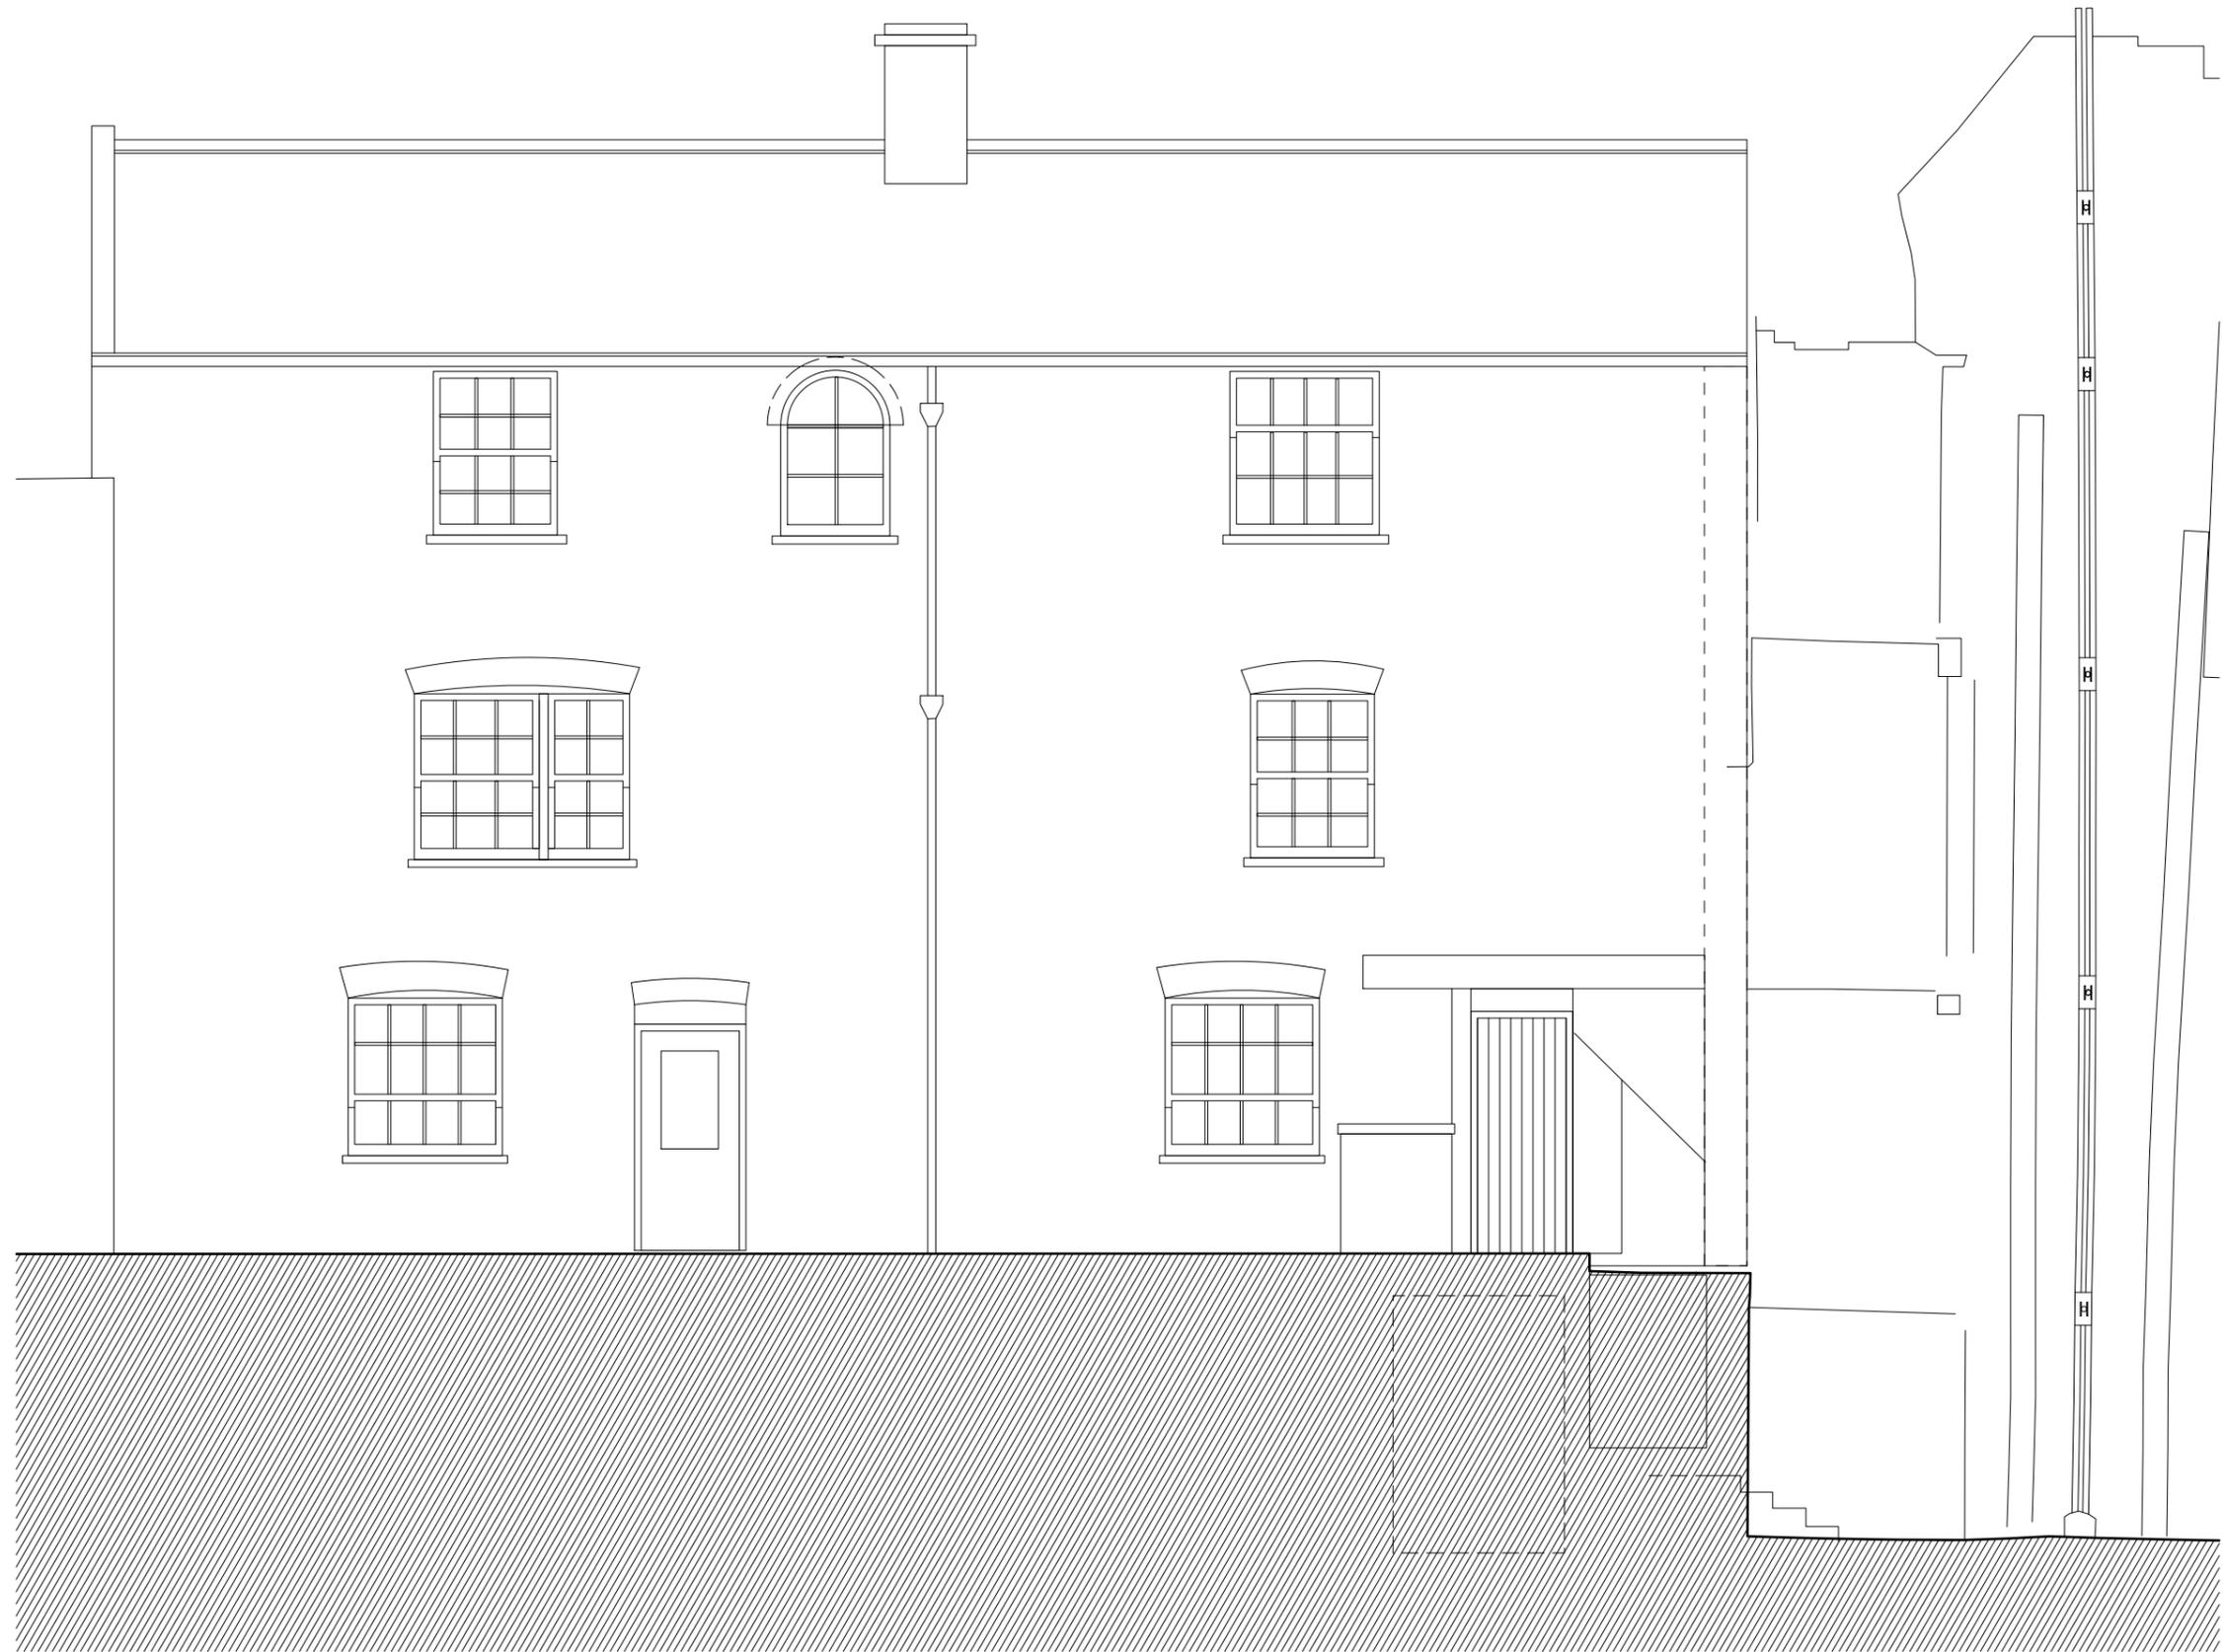
Figure 24: South-west facing elevation (based on architects drawings)

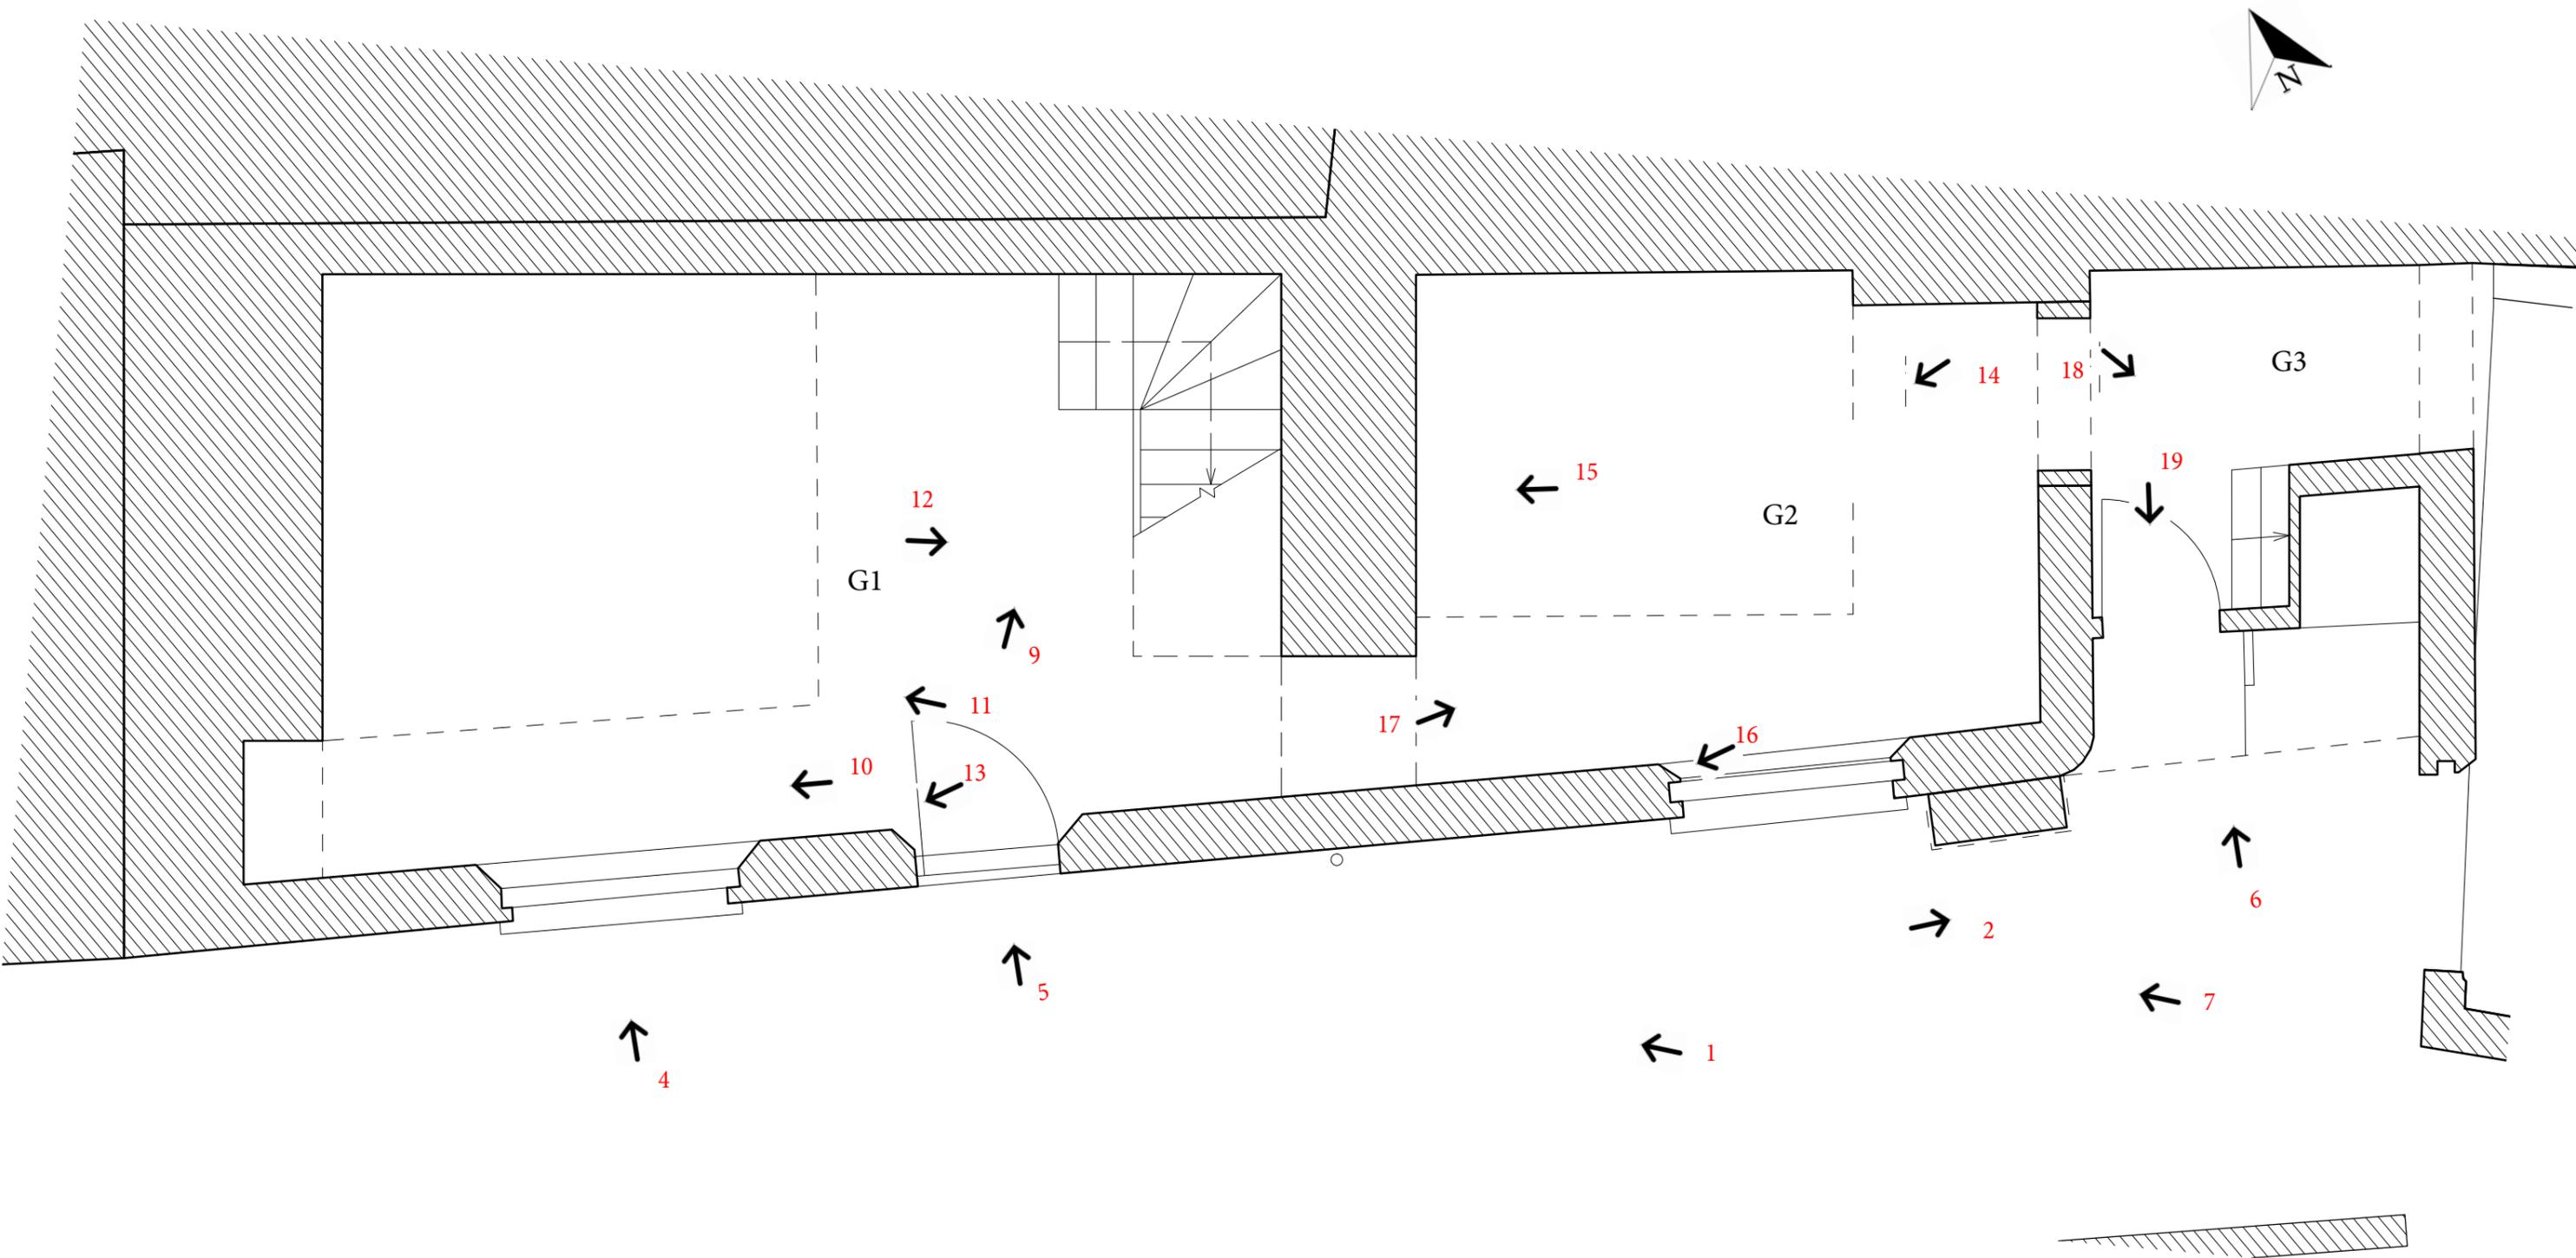
Figure 25: Ground Floor Plan showing room numbers and location of plates referenced in report (red)

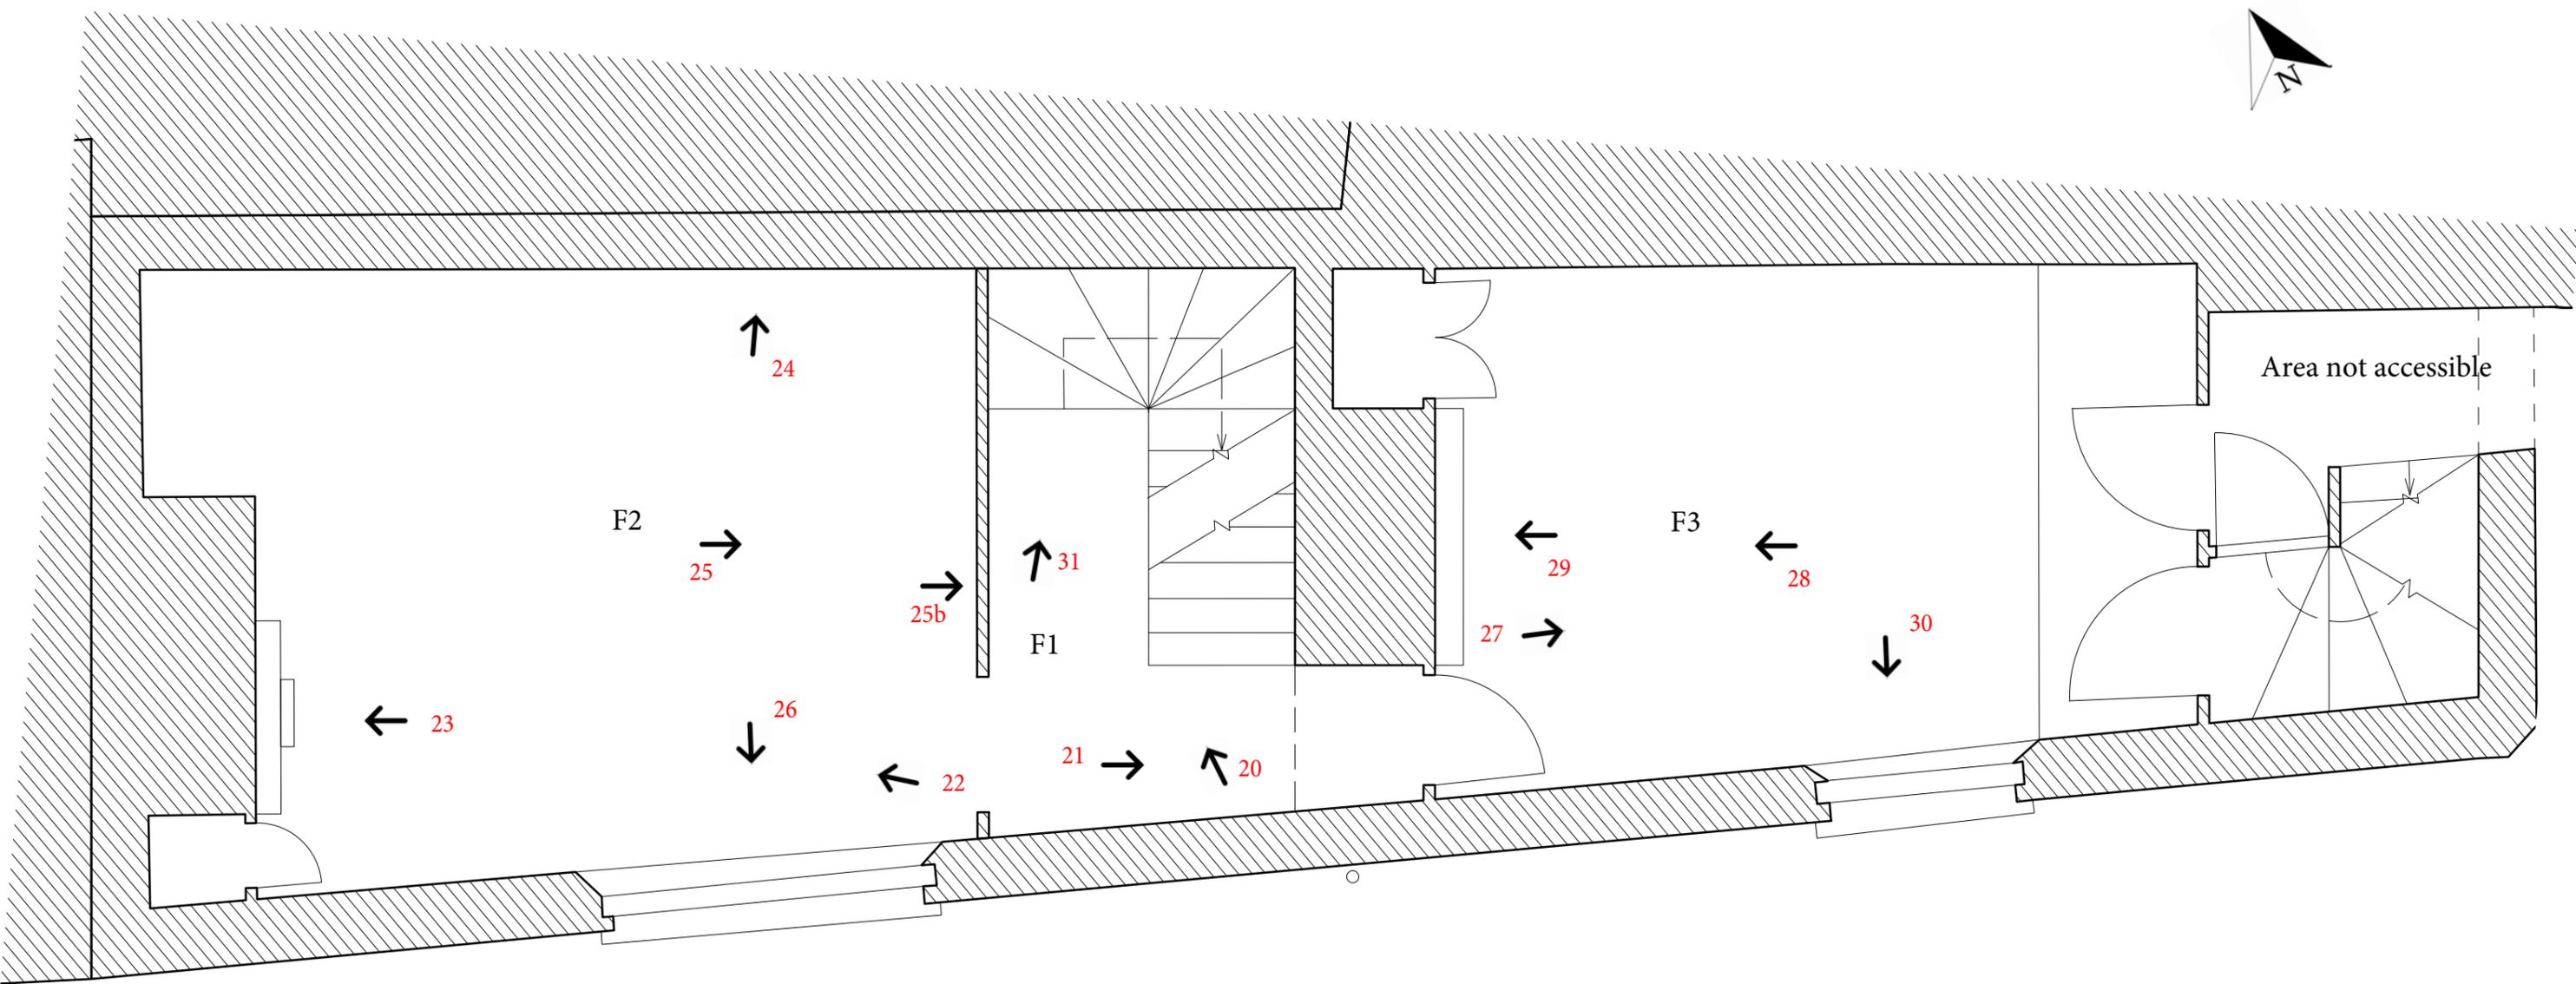
Figure 26: First Floor Plan showing room numbers and location of plates referenced in report (red)

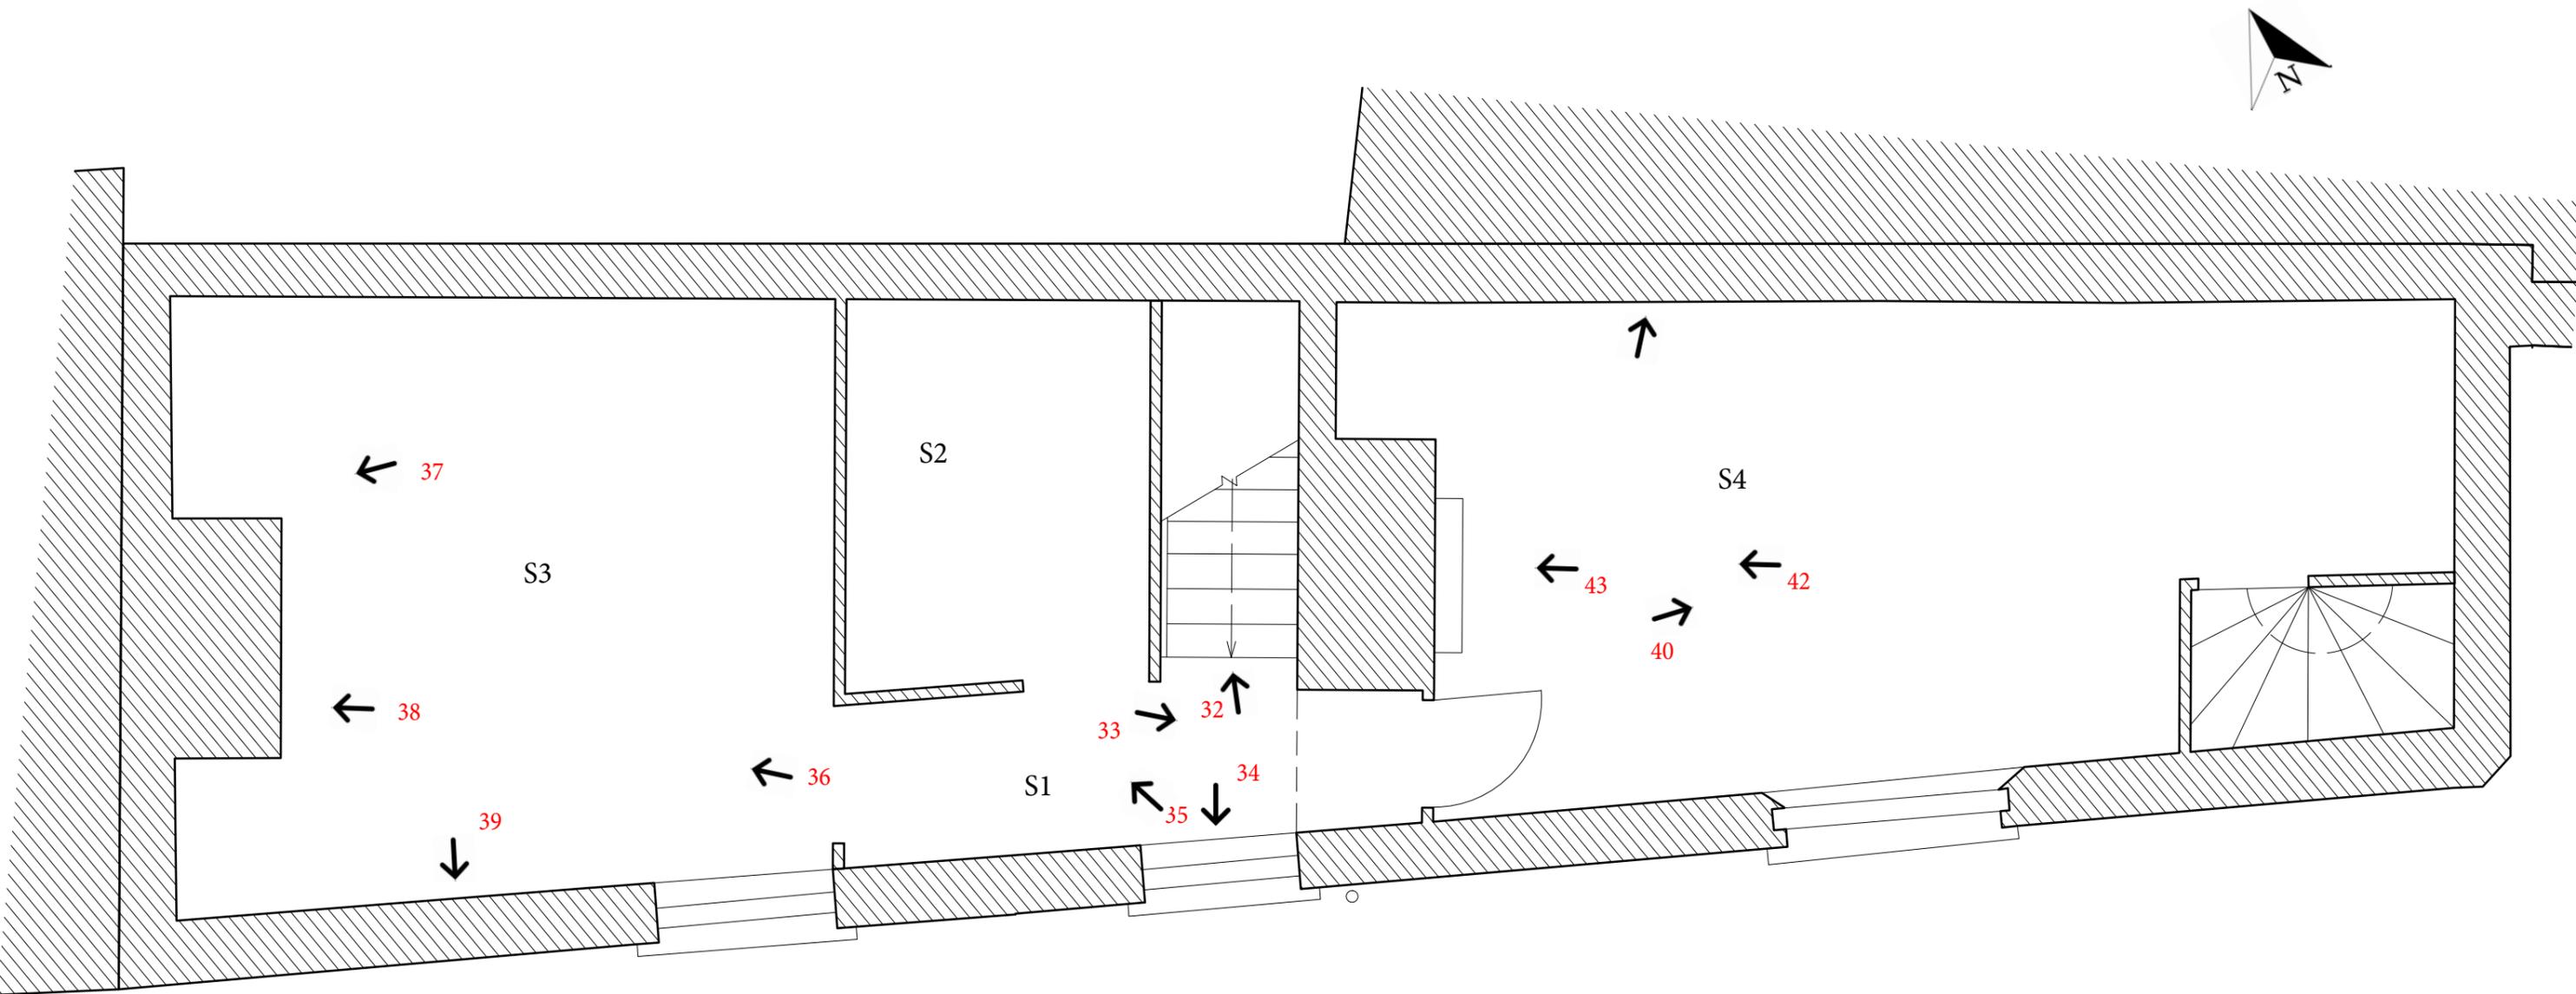
Figure 27: Second Floor Plan showing room numbers and location of plates referenced in report (red)

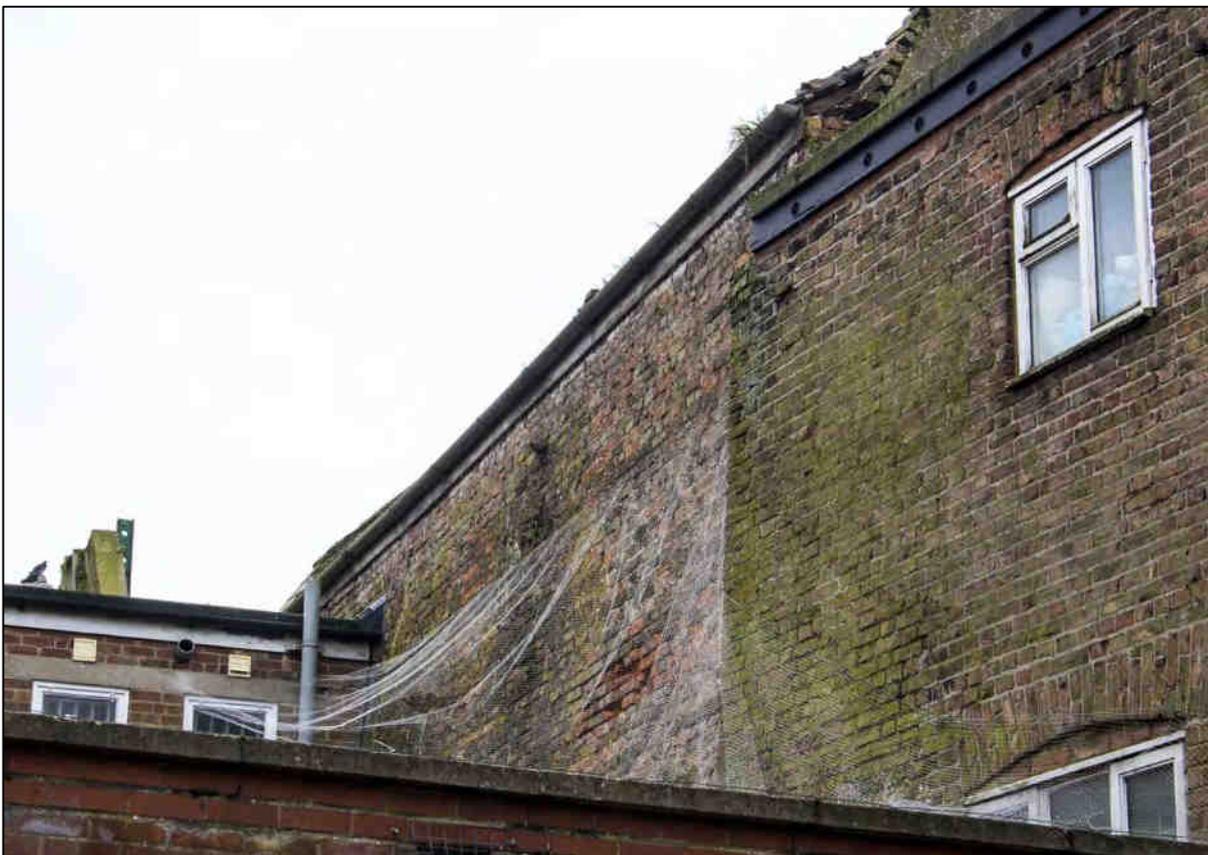
Plate 3: North-west facing elevation as viewed from rear of 25 High Street / Nene Quay

5.1.1 The building is constructed of un-frogged, handmade red brick laid mainly in English bond at ground floor and Stretcher bond above. A number of the bricks displayed horizontal pressure marks a result of the soft unfired clay brick being stacked or arranged for drying. The changeover from diagonal pressure marks to 'horizontal' pressure marks in this region occurs around 1780 (British Brick Society, 1997). The building has three storeys (Figures 23 and 24) under a pitched grey Welsh slate roof, with some localised replacement using asbestos tiles. It is rectangular in plan adjoining No 2 Nene Quay at the north-western end and exposed at the south-eastern end where the former High Street part of the property collapsed. The entrance to the building is on the south-west elevation and the north-eastern elevation wall forms part of the site boundary at the rear of 25 High Street (Figure 2, Plate 3).

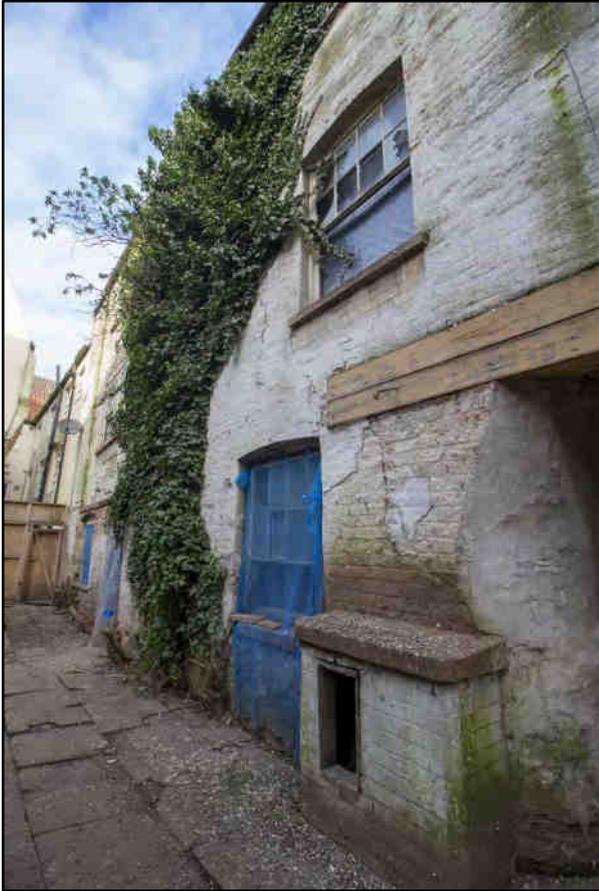
Plate 7: South-west facing elevation and courtyard looking towards alleyway to Nene Quay

5.2.4 Evidence of significant historical movement was noted as the window openings are not square and cracking has occurred in a number of locations. This elevation wall also appears to bow outwards over its height (Corcoran, 2018). Further damage appears to have been caused by significant roots at ground floor level.

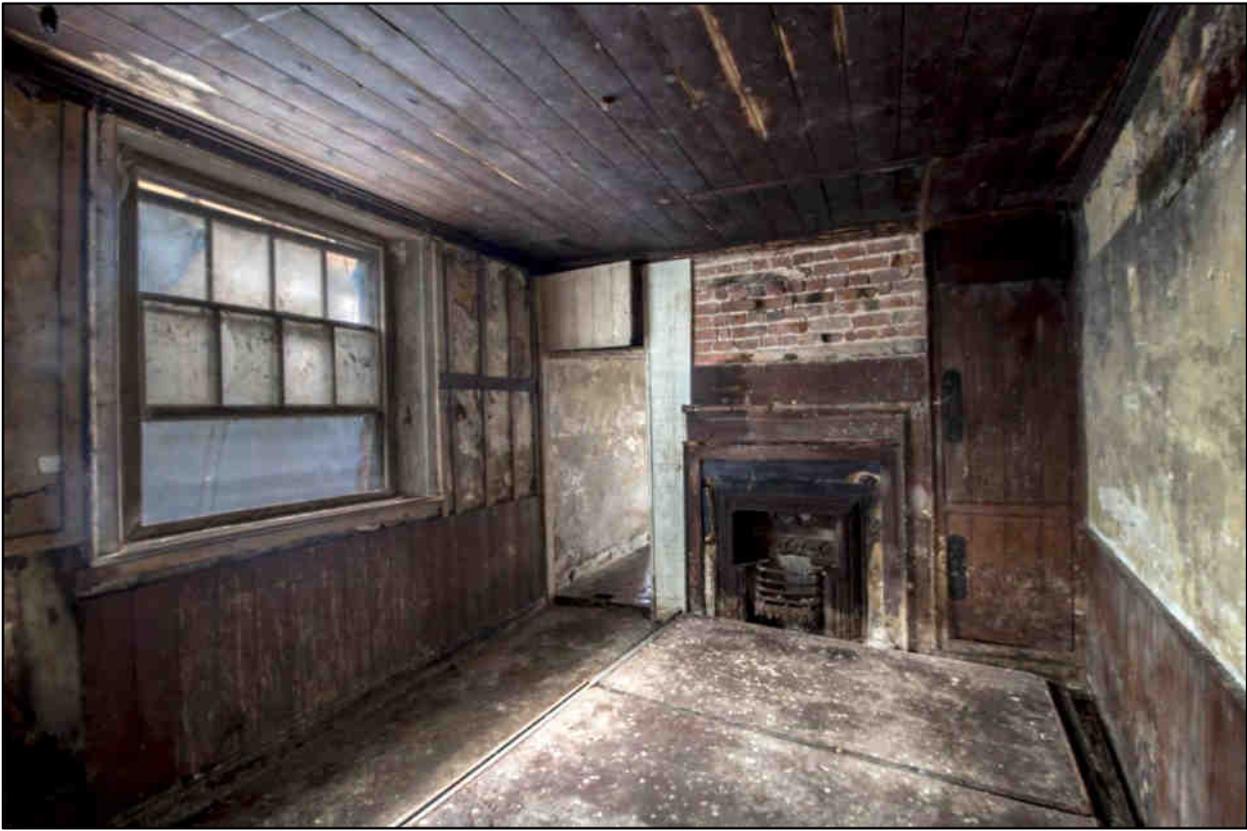
Plate 14: G2

5.3.7 This room measured approximately 3.73m x 2.92m-3.17m (at its widest point). The floor was covered with cement and the ceiling was covered with wooden boards running the length of the room (plate 14). The walls appeared to previously fully covered with wooden panels – where no longer present the battens to support them were visible. The wall and ceiling panels had been painted with a dark wood stain/paint.

5.3.10 The ground floor window as noted on the south-western elevation was intact but wedged open. It comprised a two-part timber vertical sliding sash with eight panes over four (plate 14). On the right of the window recess was a small iron fitting which has been identified as a rack pulley (Plate 16). Rack pulleys were used to control blinds or curtains before the invention of spring-loaded roller blinds. A rack pulley was screwed onto the side of a window frame, and was used to control the tape or cord that raised and lowered the roller blind by holding it in place at the desired level. This particular example probably dates to around the mid-19th century (www.oldhouseliving.com).

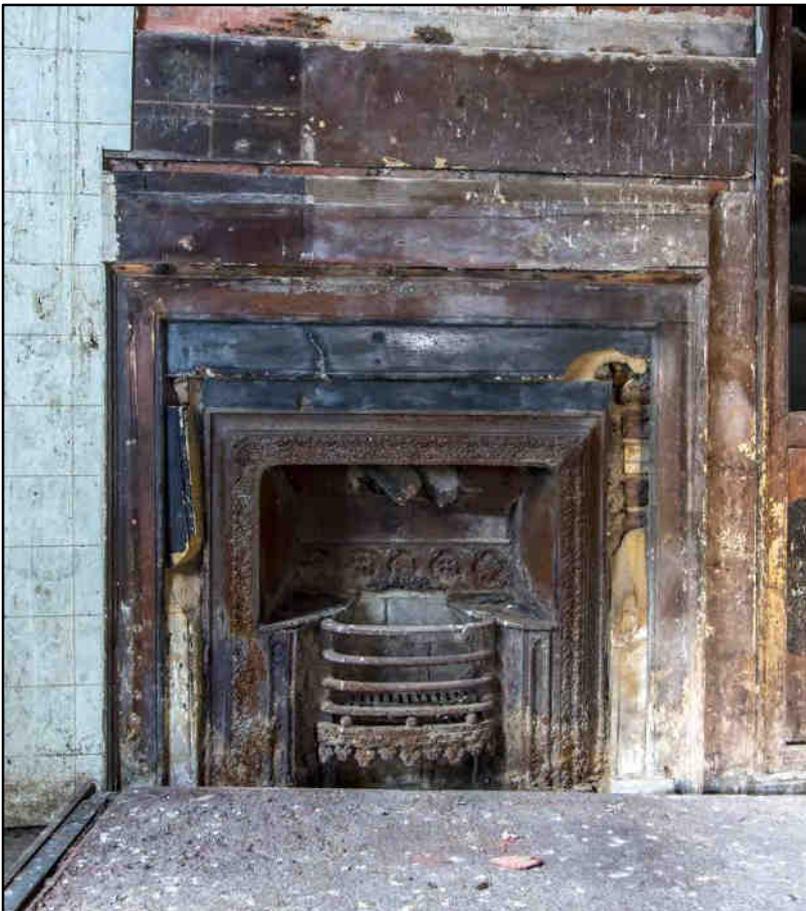
Plate 15: Hobgrate, G2

5.3.9 At the western end of the room was a fireplace with decorative cast iron hob grate with stone and wooden architrave (plate 15). The section of surround immediately above the opening was stone and had been stained black to imitate less affordable marble. Similar examples of hobgrate and fire surround identified indicate there may date to the late 18th or early 19th century (Yorke 2007a). To the right of the fireplace there is a wooden cupboard and shelving unit built into the recess. The curved edges on the shelves is noted as being unusual and slightly impractical.

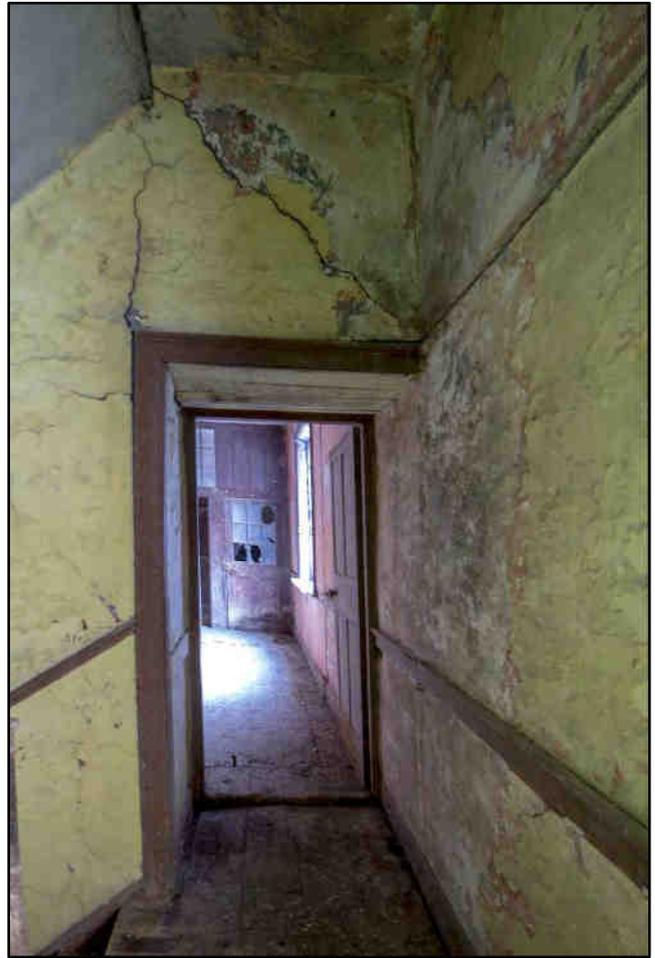
5.3.20 The area above the doorway into F3 revealed evidence of building movement with a large diagonal cracking in the brickwork (plate 21)

Plate 21: F1 looking towards F3 with cracking in brickwork above

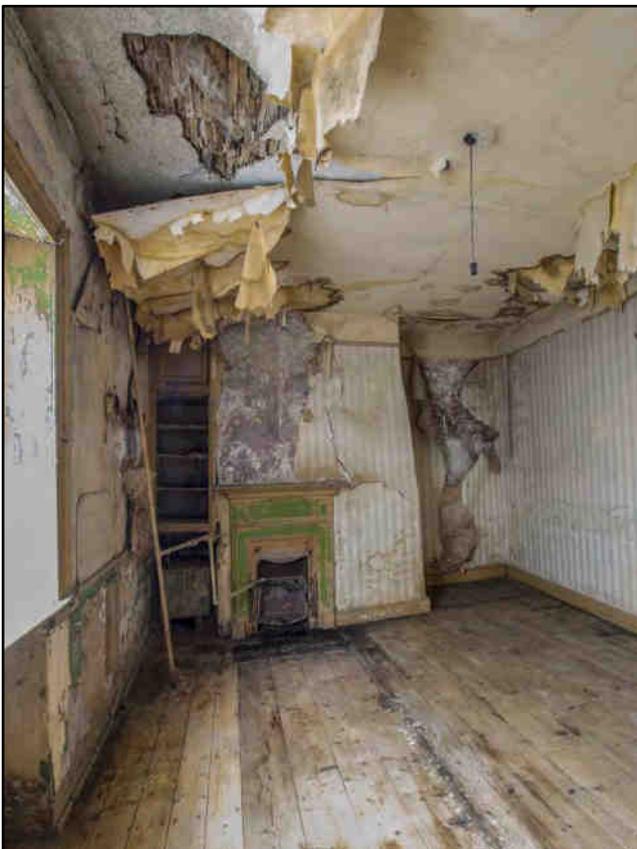
Plate 22: F2

elevation is evident (plate 22), supporting the suggestion of a lean as noted from the exterior. Cracking in the chimneybreast is further evidence of structural movement.

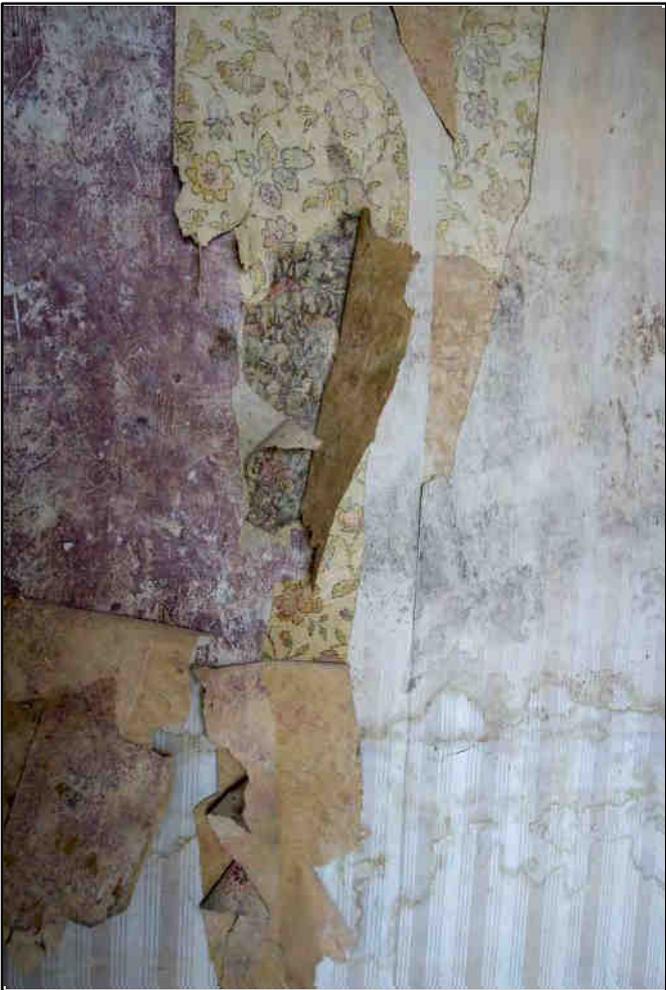
Plate 24: Detail of wallpaper layers, F2

5.3.24 Several layers of patterned and floral wallpapers were noted on some sections of wall (Plate 24), the earliest of which, a pattern with deep, rich coloured print may date to the 1880s and be representative of the Arts and Crafts style of the period, similar to that of William Morris. The latest paper in this sequence combining a floral motif with geometric pattern may date from the 1930s (Hendon, 2018).
