**Building at Rear of 24 High Street, Wisbech,
Cambridgeshire : Historic Building Recording**

June 2019

Building at Rear of 24 High Street, Wisbech, Cambridgeshire: Historic Building Recording

Event No. ECB4580

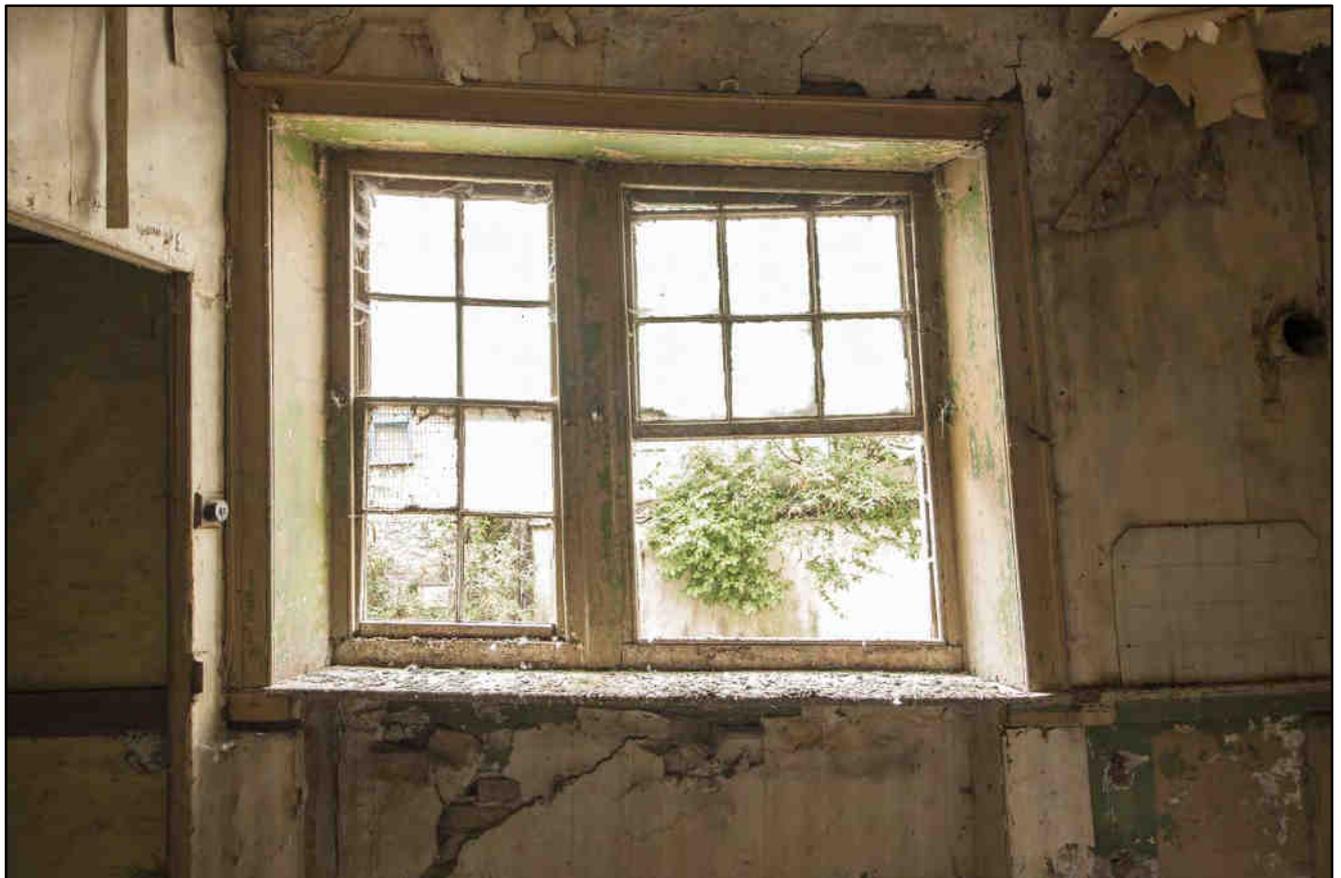
Plate 26: Window on south-west elevation as viewed from F2

5.3.26 Closer inspection of the fenestration reveals a two part sliding sash timber framed windows; four over four panes on the left and six over six panes on the right (plate 26). The opening is splayed allowing maximum light into the room. Beneath the cill, the window recess continues to the floor – possibly indicating a wider opening originally for loading door. Layers of whitewash and paint on the external wall made it difficult to confirm this. A Bakelite light switch was also noted in this room.

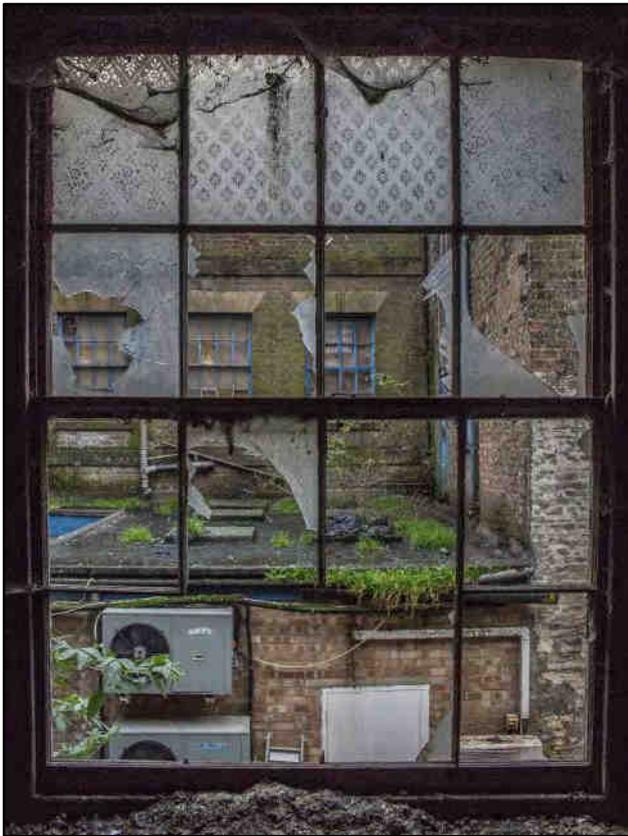
Plate 30: Vertical sliding sash window with frosted and etched glass pane, F3

5.3.31 Closer inspection of the window in this room revealed a wooden framed vertical 16 pane sliding sash with 8 over 8 pane arrangement (plate 30). Most of the panes had been broken apart from the upper four which had decorative etched glass and where some glass remained in the panes beneath these panes were sandblasted. This may indicate this room was a living space and privacy was required from activities in the out buildings opposite.

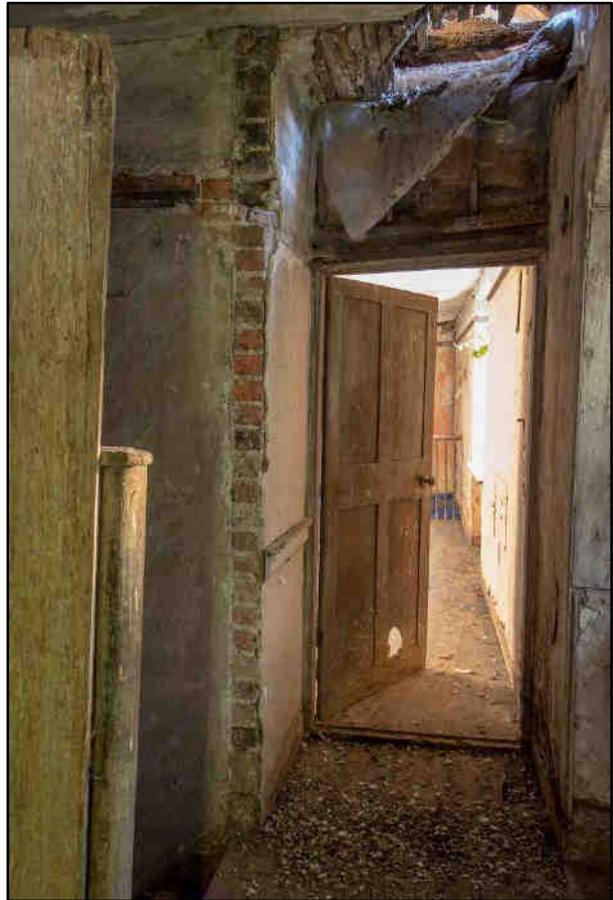
5.3.35 Significant damage caused by water ingress from the roof could be seen at the top of the stairs revealing the lath and plaster ceiling (Plate 33).

Plate 33: Evidence of damage from water egress, S1

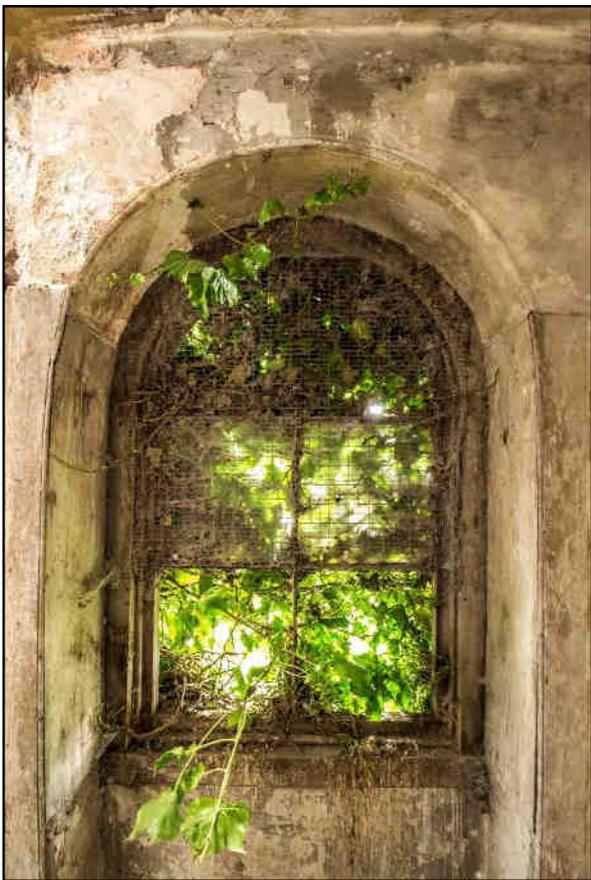
Plate 34: Window on south-west elevation as viewed from F2

5.3.36 On the wall opposite the top of the staircase was a timber-framed fixed arched window as noted on the south-western exterior elevation (plate 34). The widow had thin glazing bars and would have allowed light into the central staircase area. The length of the recess for the window continued to the floor and the outer edge of the plaster included a moulded detail.

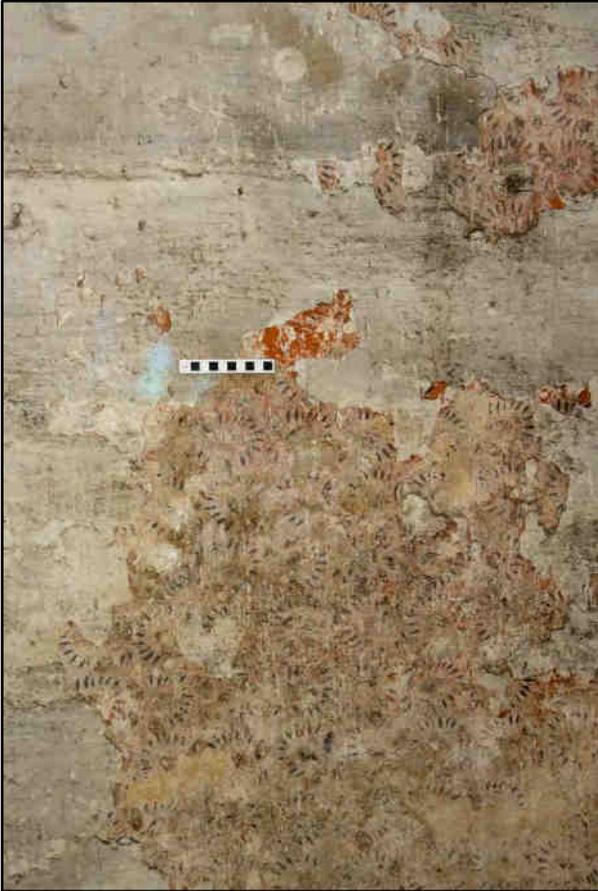
Plate 39: Stenciling detail, S3

5.3.43 The walls were plastered/lime washed and where sections of the plaster had failed, a decorative stencilling or stamping was revealed (plate 39). This may have been a more affordable alternative during a period when wallpapers and

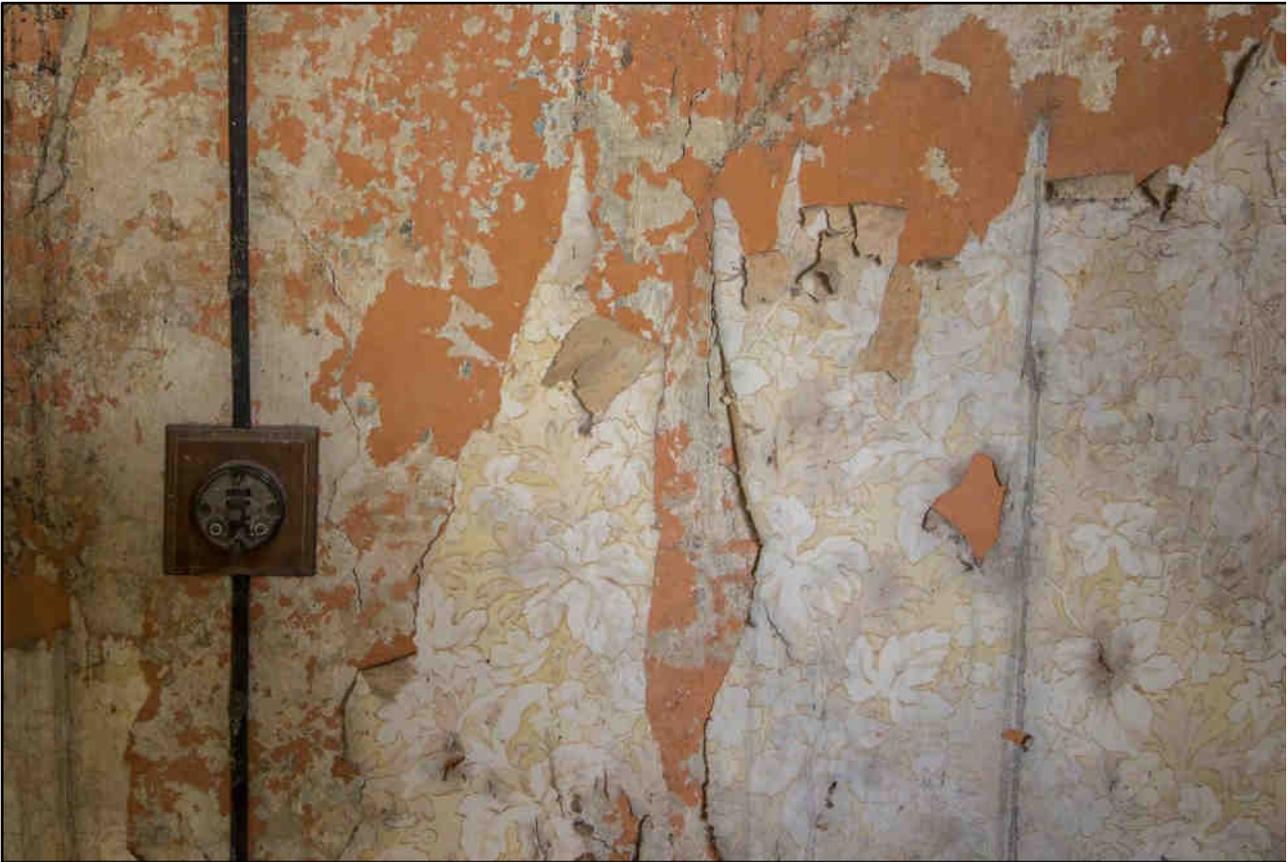
Plate 41: Paint and paper wall coverings, S4

5.3.47 The walls were plastered and painted with a floral white and yellow wallpaper peeling from the surface. Behind the wallpaper, evidence of an orange painted scheme was noted (plate 41). A Bakelite electric light switch mounted on wood block was noted on the wall – typically dated to the 1920s/30s.

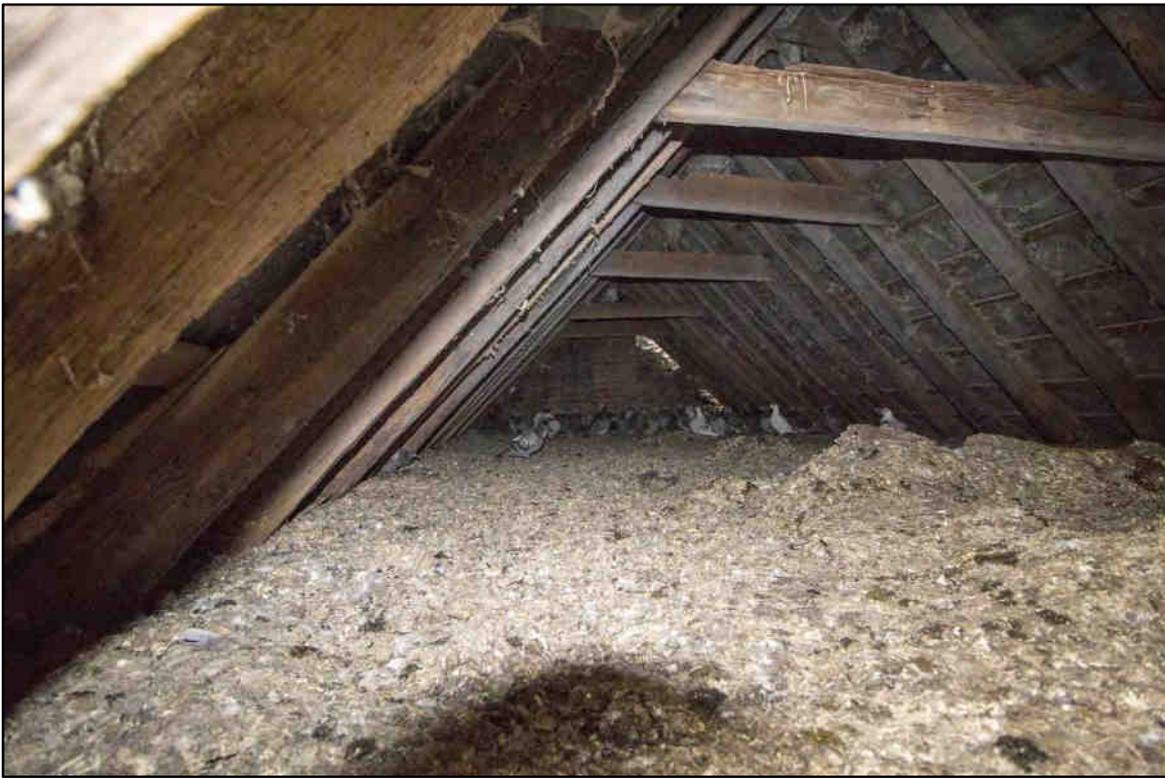
Plate 45: Roof space as viewed from loft hatch, towards north-west

5.3.53 Images suggest the building has a collar roof with a tie member to connect the rafters higher up the slope. There is also suggestion of repair at the south-eastern end of the building evidenced by replacement machine sawn upright timbers (plate 45).
